Goldfield Heap Leach Project: 100 Year Heap Leach Effluent Closure Configuration

Guillermo Larios*, Kappes Cassiday & Associates, USA

Abstract

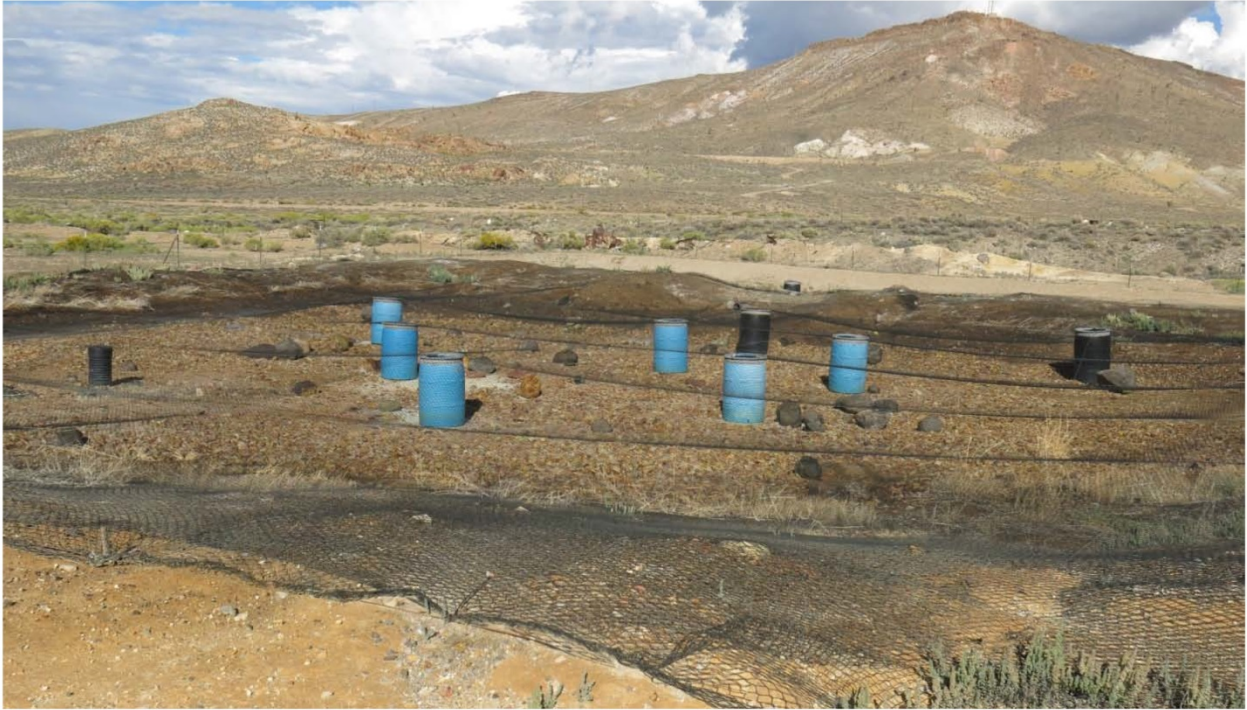
Figure 3: Evaporation Pond #1

The larger of the two evaporation ponds, Evaporation Pond #1, receives effluent discharge directly from the heap. It covers approximately 8,984 square feet, including the outer berm, and with maintenance

of one foot of freeboard, has a maximum capacity of 6,837 cubic feet. Evaporation Pond #1 was constructed in 2002 within the original primary heap overflow pond as a double-lined system with leak detection. The primary heap overflow pond was partially backfilled, and the evaporation pond was constructed in the remaining cavity. The current structure of Evaporation Pond #1 consists of, at its base, HDPE liner recovered and reused from the base of the original pond, which in turn is overlain by six feet of local area soil. This soil layer is in turn overlain by a second HDPE liner, a one foot layer of compacted fines to protect the HDPE lining, 1.5 feet of sandy soil, and finally six inches of two-inch rock fill as shown in Figure 2. The bottom of the overflow pipe is a minimum of 1.1 feet from the top of the layer of rock fill. This profile yields roughly 1.6 feet of available pond depth, consisting of six inches of two-inch rock fill, and 1.1 feet of open containment.

There are currently two evaporation ponds connected by an overflow piping system, as presented in Figure 2. The system, as currently designed and configured, accommodates a total of 13,247 cubic feet of solution and meteoric run-off, while maintaining a minimum of one foot of freeboard at all times. The Evaporation Pond #1 is illustrated in Figure 3 and Evaporation Pond #2 in Figure 4.

The pond system was modified in 2010 to replace and reconfigure the pipe overflow system between the two evaporation ponds to increase the available volume of Evaporation Pond #1. The overflow is lined with the same HDPE liner and one foot layer of compacted fines as the two evaporation ponds. Two polyvinyl chloride (PVC) pipes laid side-by-side connect the ponds through the ditch. The overflow height is a minimum of 12 inches from the top of Evaporation Pond #1, which constitutes the minimum operational one foot of freeboard described above.

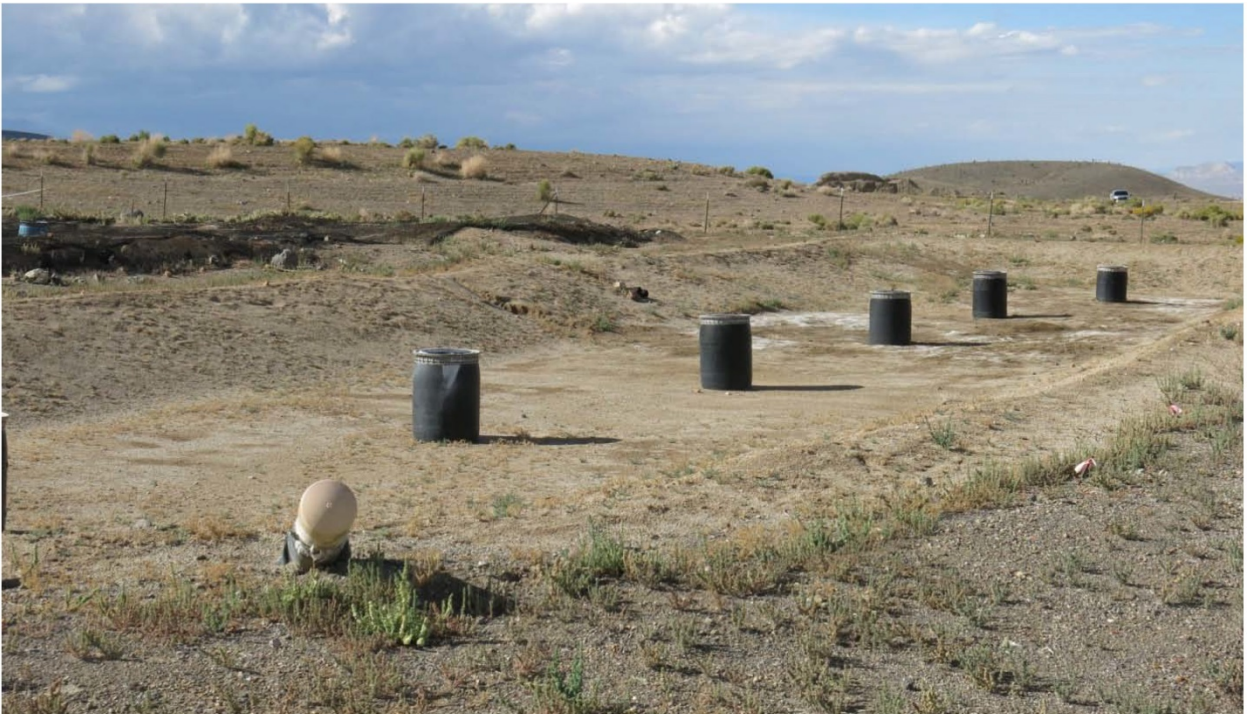
Figure 4: Evaporation Pond #2

The second evaporation pond, Evaporation Pond #2, was constructed in 2005 with the same base fill and liner profile as Pond #1, with the exception that no backfill underlies the base HDPE liner. Evaporation Pond #2 is 2.8 feet deep from the base of the pond to the berm crest, and does not contain any rock fill. This profile yields a rough containment volume of 6,410 cubic feet with maintenance of one foot of freeboard.
